DEPARTMENT OF TRANSPORTATION

Office of Structural Materials

Contract #: 04-0120F4Cty: SF/ALA Rte: 80 PM: 13.2/13.9File #: 69.15**SOURCE INSPECTION REPORT****Resident Engineer:**Pursell, Gary**Address:** 333 Burma Road**City:** Oakland, CA 94607**Report No:** SIR-001907**Date Inspected:** 16-Mar-2010**Project Name:** SAS Superstructure**OSM Arrival Time:** 700**Prime Contractor:** American Bridge/Fluor Enterprises, a JV**OSM Departure Time:** 1900**Contractor:** Zhenhua Port Machinery Company, Ltd (ZPMC), Changxing Island **Location:** Chang xing Dao, Shanghai**Quality Control Contact:** Mr. Don Walton**Quality Control Present:** Yes No**Material transfer:** Yes No N/A**Sampled Items:** Yes No N/A**Stock Transfer:** Yes No N/A**OK to Cut:** Yes No N/A**Rebar Test Witness:** Yes No N/A**Delayed/Cancelled:** Yes No N/A**Other:** Coating Inspection**Bridge No:** 34-0006**Component:** See Below**Bid Item:** 77, 78, 79**Lot No:** B #204**Summary of Items Observed:**

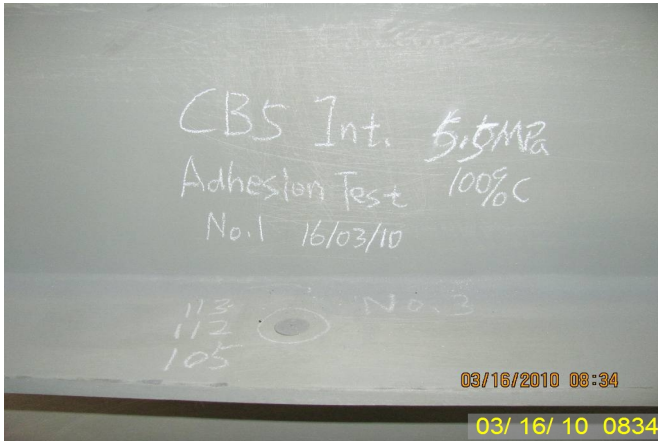
1. An inspection was requested on the Cross beam internal surfaces CB5 -1 Set, for adhesion test, vide request no. 2885 at Painting workshop no. 1. This Caltrans inspector observed, ABF inspectors Mr. Wei performing adhesion test by Dolly method at 3 places. The results found are 5.5Mpa, and 5.7 Mpa in 2 places. The other dolly failed to comply with Dolly test because of Glue failure. It was found, ABF Inspectors asked ZPMC to restick the Dolly and resubmit the notification for adhesion test.(Photo of result attached). International protective coatings technical service representative Mr. Li peng was found present during the course of this inspection process.

2. An inspection was requested on OBG Cross beam external surface CB4 at the Ship for the transportation of OBG(Port no. 5) vide inspection request no. 2888 for DFT check and final acceptance inspection prior to transportation from ZPMC. This Caltrans inspector observed, ABF inspectors Mr. Sun, performing DFT check and the results found to be in the range of 234 to 275 which is acceptable as per contract documents. Mr. Bill Howe from Caltrans were present during the Inspection process and final acceptance for finish coat application were given by him. International protective coatings technical service representative Mr. Li peng was found present during the course of this inspection process.
